# Manhole Inspection Summary

Manhole # S31UU\_001MH

Insp Date: **8/27/08 11:32 AM**

**Location** Address: **2939 HUNTINGDON AVE**

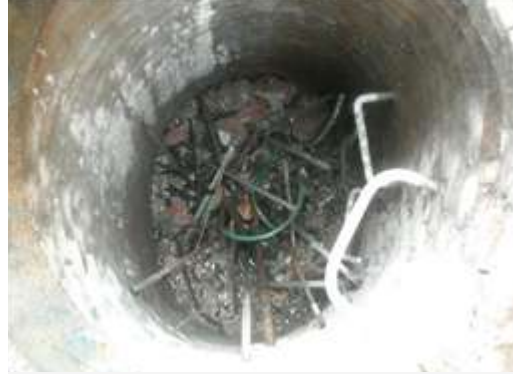
Top View

Channel debris.

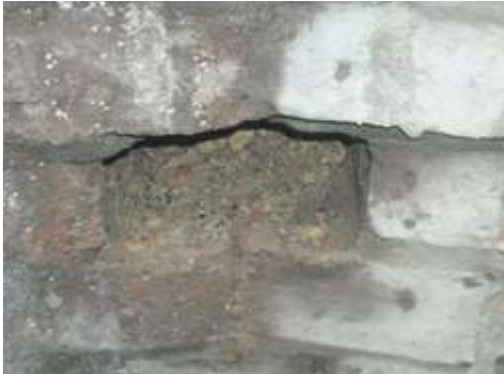
Defect

Barrel deterioration and infiltration.

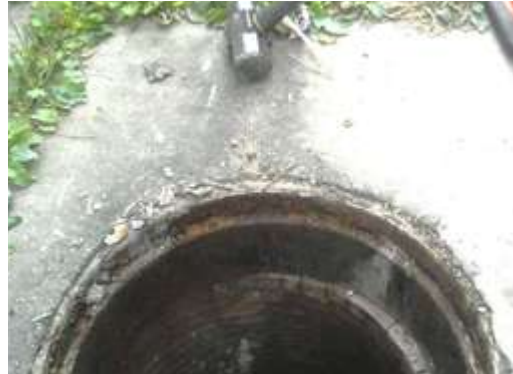
Defect

Frame leaks. Frame offset. Corbel deterioration and infiltration. Barrel infiltration.

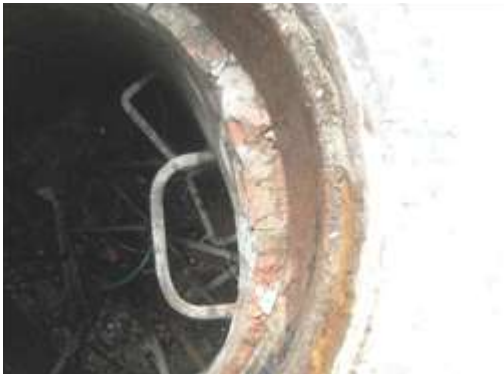
Defect

Frame leaks. Frame offset. Corbel deterioration and infiltration.

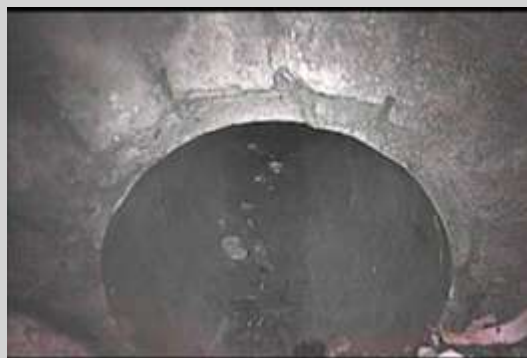
Pipe Out @ 12 O'Clock

Infiltration: **Evidence**
